**Test Report**  
**944-7119076-2/DG**

**Testing brake bleeder valves made of steel**

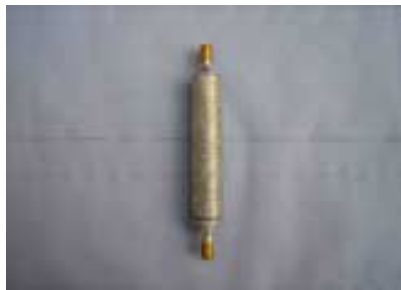
Test cylinder with test sample steel (top)

**Test parameter Test No. 1: Salt spray test**  
Test specification: EN 60068-2-52 Severity 3  
Corrosion test with one test sample of the bleeder valve made of steel as well as one banjo bolt made of aluminium anodized in a natural hue. The top parts of the valve were protected with the aluminium dust cover provided.  
For the purpose of testing, the test samples were screwed into an aluminium cylinder.  
Salt spray cycles of 4 x 2 hours respectively with 22 hour long storage in damp conditions.  
Subsequently, storage in damp conditions for a further 3 days with concluding reporting.

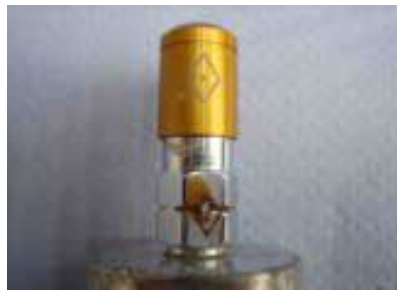
Beginnings of corrosion on steel version

**Test result Test No. 1: O.k.**  
Comments on test result: After completing the salt spray test, the surfaces of the test sample (dust cover, steel adapter, aluminium banjo bolt) showed crystalline salt residues. On one side of the adapter, the test sample made of steel showed signs of corrosion (see photo). After removing the dust cover, no corrosion was detectable on the steel bleeder valves. After removing the salt residues, there was only the small area of corrosion on the hexagon head of the steel adapter noticeable. It was possible to remove this small area of corrosion by scratching it off with a finger nail and subsequently cleaning it with a cloth.

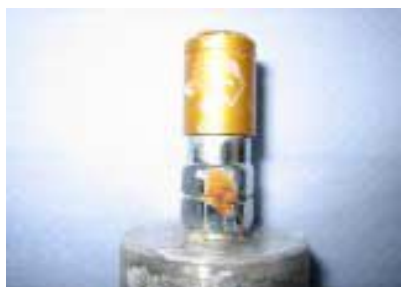
Test sample steel/steel

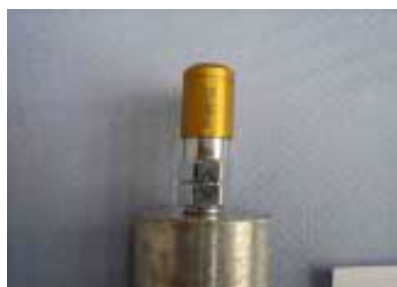
Test sample steel after removing salt residues

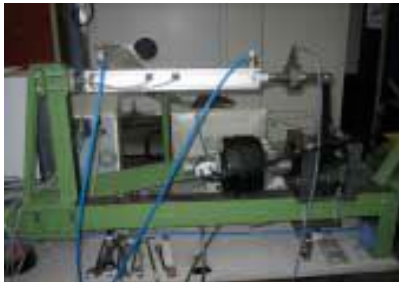
Test set-up with pneumatic and master cylinder

**Test parameter Test No. 2: Continuous pulsating load**  
Test machine: Pneumatic cylinder Festo above hydraulic cylinder on test block with valves  
Control: PC using DasyLab, Festo valves  
Type of signal: 0-150 bar, half sine  
Frequency: approx. 0.6 Hz  
Load changes: 125.000  
Opening of bleeder valves: 15 times per system across 125.000 load changes

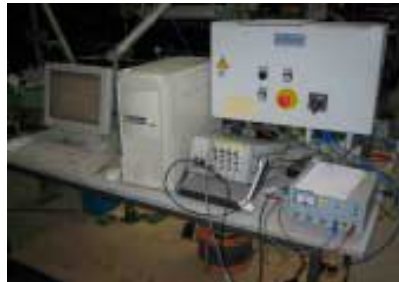
Control and monitoring unit

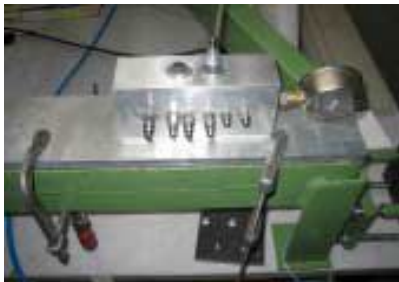
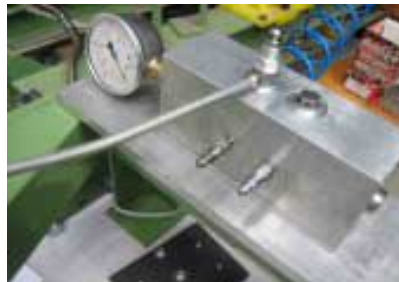
Test carrier with test samples

Comments on test result: All test samples survived the continuous run of 125.000 load changes at a pulsating load of 150 bar brake pressure without suffering any damage/leakages.

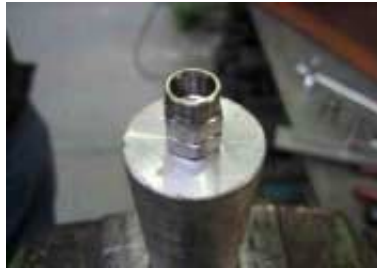
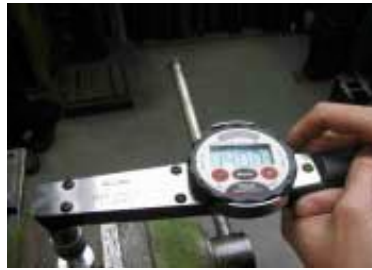
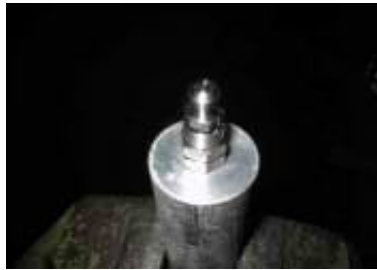
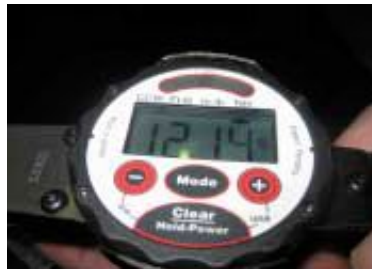
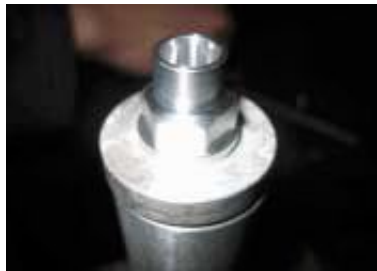
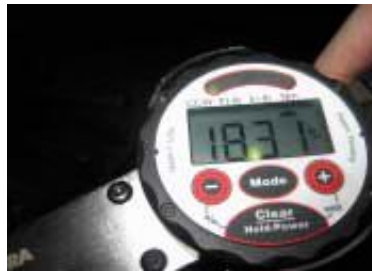
### Photographic documentation for tightening torque

Comments on test result: All test samples withstood the specified torque values without any damage.
